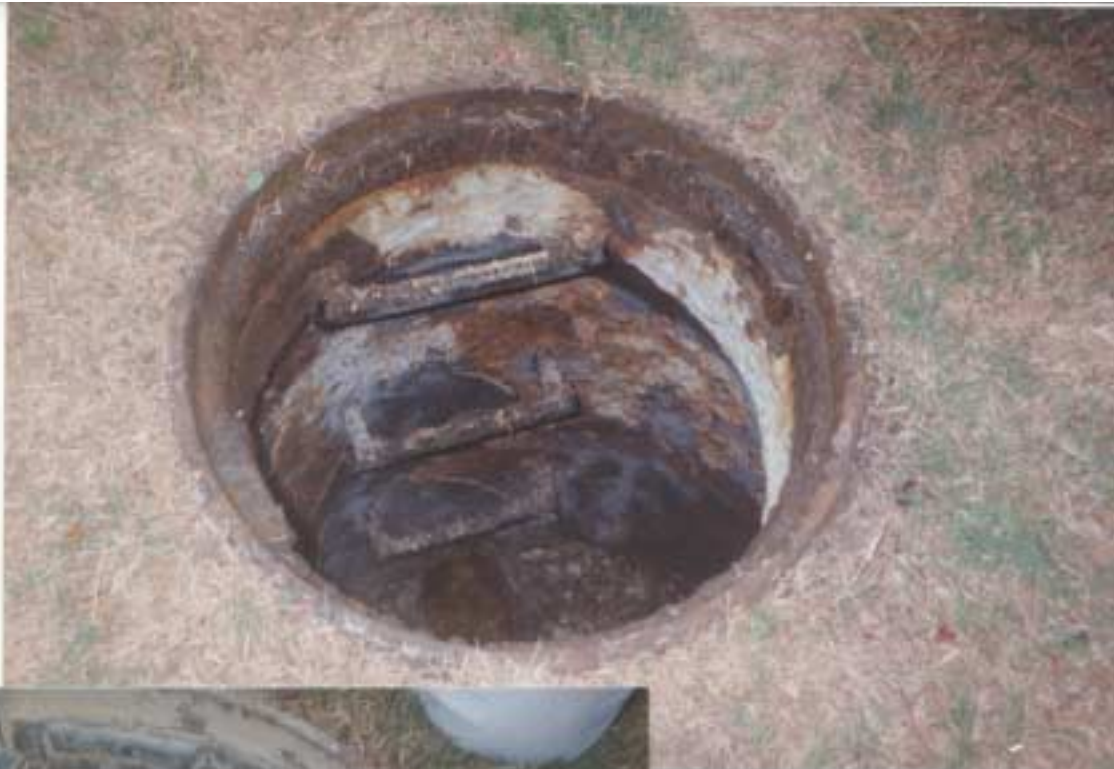
View of uncoated concrete manhole. Note the severe surface deterioration caused from exposure to sewage gas.

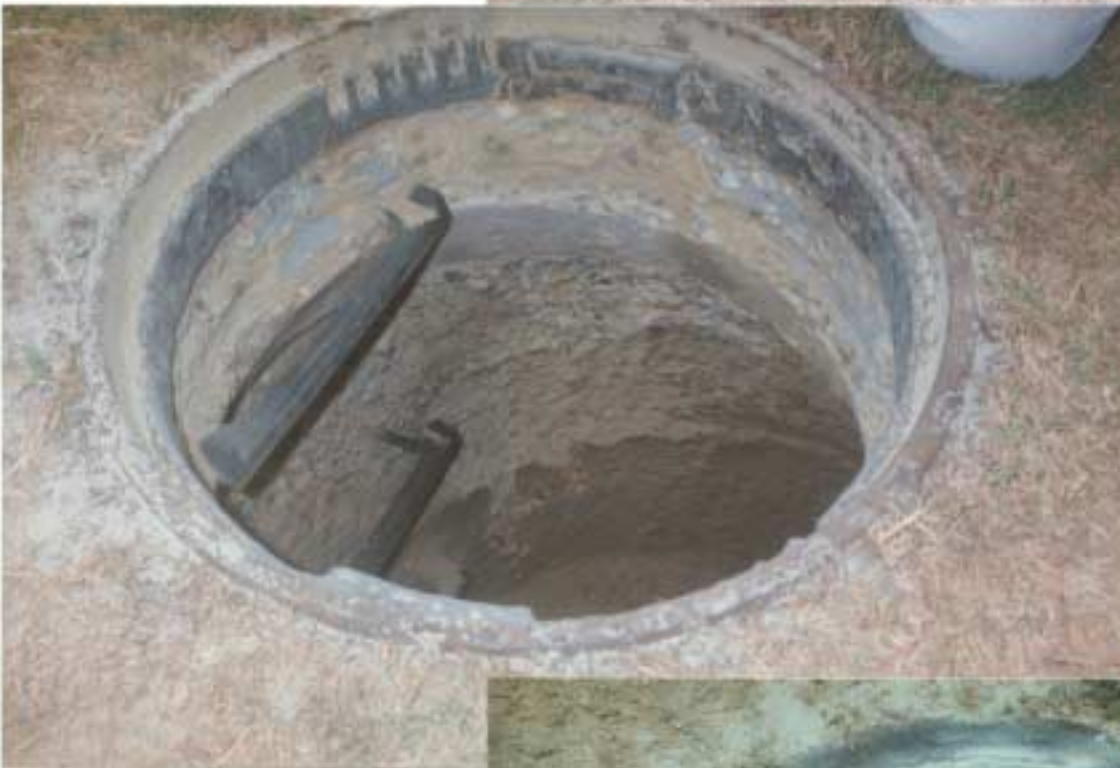
After abrasive blasting, manhole surface exhibits a very irregular substrate with exposed aggregate that would normally be smoothed with cementitious grouts or hand applied epoxy composites.
